Analysis of Failure of Pin Locator for Internal Nose Cap of a Long Range Cruise Missile

ABSTRACT

A steel pin used as a locator for internal nose cap of long range cruise missile was found in cracked condition after it was subjected to transportation, vibration and bump tests. Metallurgical investigation was carried out with the failed pin. The crack was found to be inter-granular and a thin black oxide layer was observed on the fracture surface. Based on the evidence, it is concluded that the pin failed because of quench cracking and the crack was initiated prior to tempering and zinc plating.

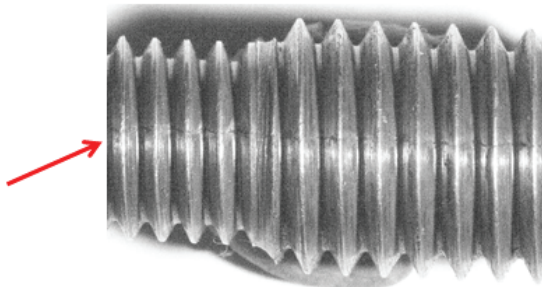
Stereo examination has displayed that the crack is present from the end of the hexagonal portion and the first thread joining position to the end of the last thread. It is to be noted that no crack was observed on the hexagonal portion as well as on the cylindrical portion of the pin. The centre portion with the crack is illustrated in Fig. 2.

Figure 2. Stereo microscopic images of pin showing crack.

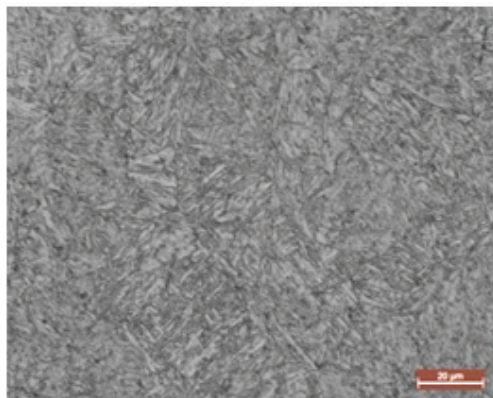
Sections of the failed components were prepared for metallographic examination and observed under optical microscope. The microstructure of the pin was seen on longitudinal directions. The etching reagent was Vilella's reagent. The microstructure provided in Fig. 3 reveals tempered martensite structure.

Figure 3. Photomicro graph of the pin in longitudinal direction showing tempered martensite structure. Etchant Vilella's Reagent.

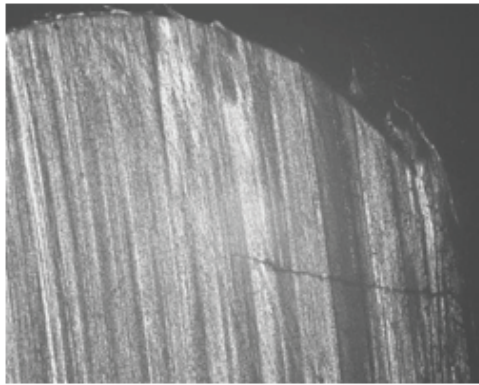
The defective pin was cut cross-sectional as per schematic presented in Fig. 4 and viewed under optical microscope. The optical micrograph shown in Fig. 5(a) reveals that the crack has propagated to a depth of 1/3rd of the diameter of the rod. The cut surface was polished and examined under optical microscopy. The optical image is given in Fig. 5(b). Figure 5(b) indicates a crack that had propagated in a zigzag pattern. To open the crack for fracture surface examination, the cross section portion with the crack was cut perpendicular to the depth of the crack along the length. After cutting across the crack length, the two mating surfaces of the crack were opened by a small amount of force and by giving a slot into the crack. The mating surfaces of the crack are shown in Fig. 6. The entire crack has shown dark black coloured surface except the force opened region which is bright.

Figure 5. (a) Optical micrograph showing crack in as cut surface; and (b) Optical micrograph showing crack after polishing.

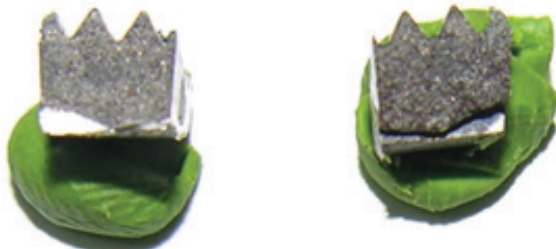
Figure 6. Photograph showing the two mating surfaces of the crack after cutting.

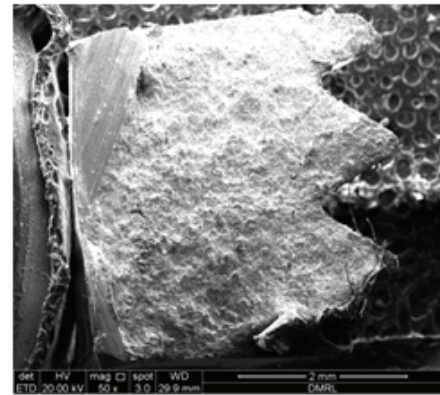
The low magnification SEM fractographs showing the fracture surface from the thread portion to the about 90 % of the fracture surface is illustrated in Fig. 7(a) through Fig. 7(d). The remaining portion showing the cut marks is the force opened region. Near the threaded portion a coating was observed along the contour of the thread while the fracture surface is covered by a thick oxide scale (Fig. 7(b)). Deep into the fracture surface intergranular fracture features covered by oxide scale was observed (Fig. 7(c)). At the junction of the fracture surface and the force opened region, rubbed fracture features and overload fracture features were observed (Fig. 7(d)).

Figure 7. (a) SEM fractograph showing fracture surfaces; (b) SEM fractograph showing fracture surface with coating and oxide layer; (c) SEM fractograph showing intergranular fracture surface; (d) SEM fractograph showing rubbing and overload fracture surface.

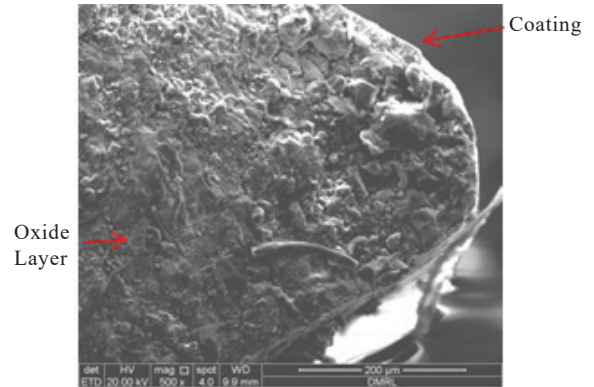
(b)

Oxide layer was noted on the fracture surface. The presence of dark colour oxide layer on the fracture surface, as shown in SEM fractographs (Fig. 7(b)), indicates that the fracture surface has been exposed to high temperatures. This confirms the fact that, crack was initiated before tempering because of the stresses generated during quenching. The intergranular nature of the crack and the presence of oxide layer on the fracture surface suggest that the crack has occurred after quenching and prior to tempering. Fracture surface also revealed presence of Zn. The presence of zinc on the fracture surface till the end of the fracture region confirms that the crack existed prior to the zinc plating.

In view of the above, it is recommended to austenitize the pin in the range of 870-890 °C instead of 915 °C and quench in oil in place of water. Tempering can be done in the range of 480-520 °C followed by oil quenching and not air cooling for this class of material having dimension in range of these pins.

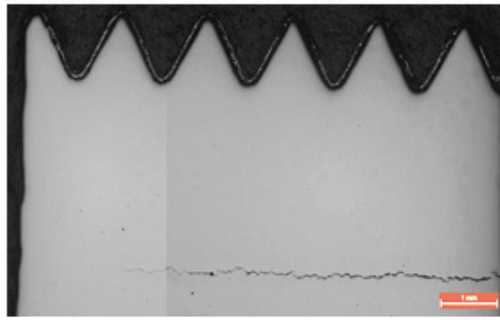
Optical micrograph given in Fig. 8(a) shows the zigzag pattern of the crack. The area near the crack surface has

Figure 9. (a) Optical photomicrographs showing the zig-zag pattern of the crack in unetched condition; and (b) Optical photomicrographs showing the zig-zag pattern of the crack in of the crack after etching.

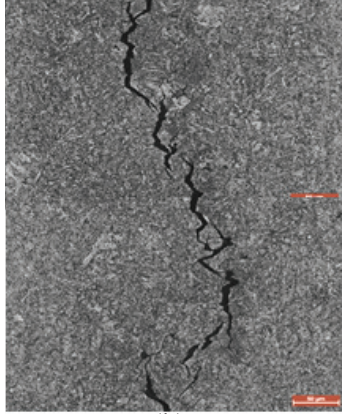
(b)

revealed cracking along the grain boundaries as seen in Fig. 8(b). EDAX analysis was carried out on the coating of the thread has shown the presence of zinc in addition to matrix elements as given in Fig. 9(a). EDAX analysis on the fracture surface of the threads and on the intergranular region has also revealed the presence of zinc in association with matrix elements with the same intensity as on the coating region. On the other hand the forced opened region has revealed only the matrix elements in EDAX analysis. No traces of Zinc are seen in this region as can be seen from Fig. 9(b).

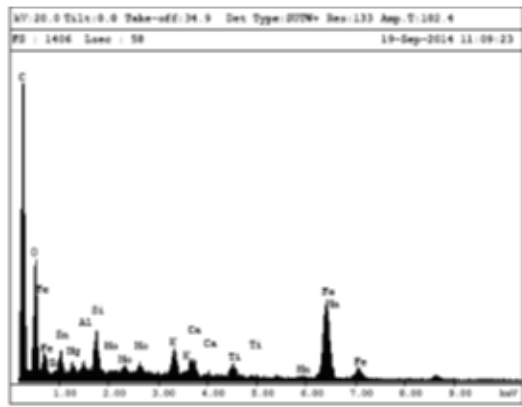
Figure 9. (a) EDAX analysis of fracture surface on the teeth showing presence of Zinc; and (b) EDAX analysis of force opened region showing only matrix elements.

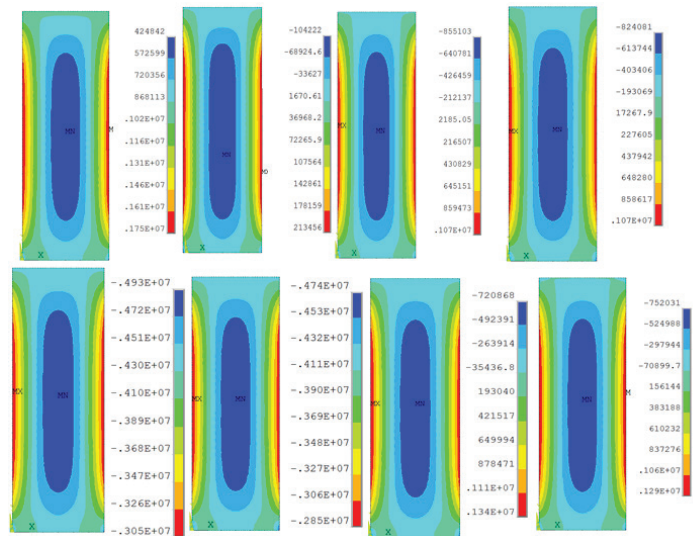
The simulation results obtained for a cylindrical steel pin is presented in Fig. 10 showing stress distribution after different time interval following initiation of quenching in air and water. It can be seen that 300 sec. after quenching the stress is completely tensile in water quenching. The maximum stress is on the surface and is around 1.7 MPa. In contrast, it is tensile on the surface and compressive in the core 300 sec. after air quenching. Further, maximum stress is quite low and equal to 0.2 MPa on the surface. After a time period of 1260

Figure 10. Simulated stress state in the pin after quenching. Water quenched after (a) 300 s, c; 1260 s, e; 1950 s, g; 3300 s and air quenched after (b) 300 s, d; 1260 s, f; 1950 s, h; 3300 s.

seconds, stress distribution is similar in both water quenched and air quenched specimen being tensile on the surface and compressive at the interior.

The maximum tensile stress is also around 1 MPa significantly low than initial stage of water quenched sample. 1950 sec. following quenching, the stresses becomes compressive throughout the pin for both water quenched and air quenched pin and the maximum compressive stresses close to 5 MPa is experienced at the core. Finally 3300 sec. after quenching, the surface becomes tensile and the core remains compressive. The differences in stress distribution in water and air quenched sample is reduced. The maximum stresses are also quite low.

consideration indicates change of stress state in the pin is in conformity to the above discussion. Importantly, the maximum tensile stress experienced by the surface during water quenching is significantly higher than that during air quenching in the initial stage of quenching. The high stress state in the surface during water quenching is responsible for initiation of the crack on the surface. The stress state becomes comparable after prolong exposure to quenching medium. This leads to the interference that quenching in the air will be able to prevent crack formation on the surface during quenching. Further since the surface of the pin was threaded, a higher stress gradient is expected resulting in crack initiation.
