Defect Investigation as a Tool for Quality Improvement

B. Gurumurthy, Y.N. Nagaraja, C.N. Nagesh, and G.S. Ravindra
Aeronautical Development Establishment, Bangalore – 560 075

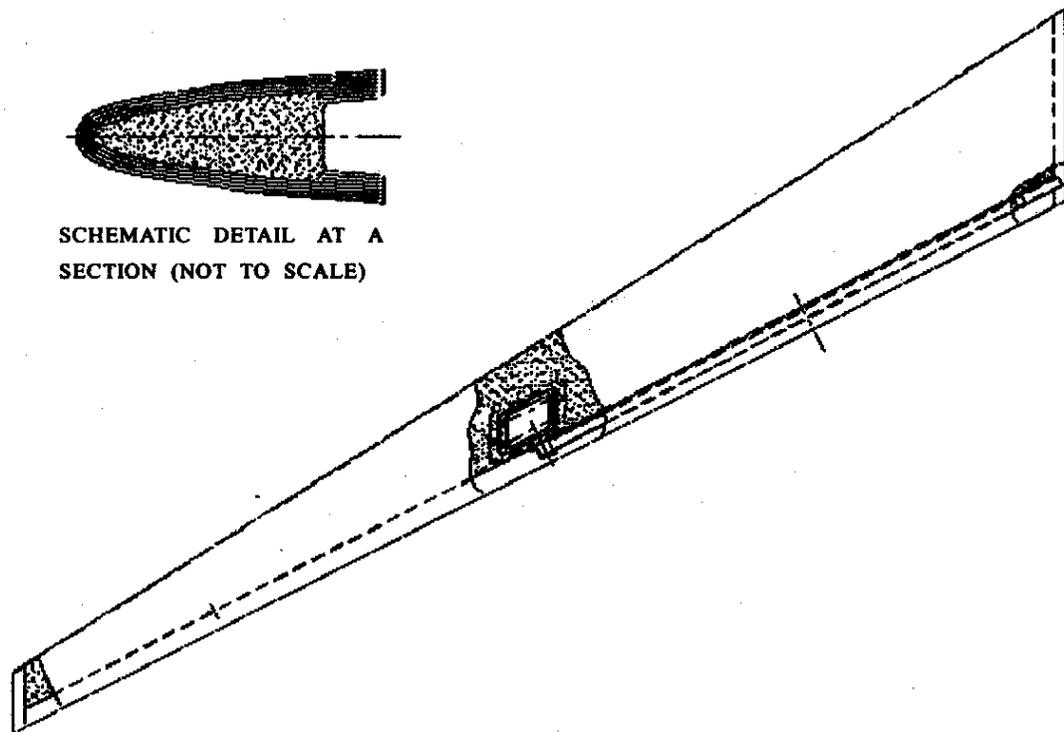
The *Lakshya* had a sweptback symmetric airfoil wing of 3 m span. The smooth profile of this wing is one of the parameters that affect the aerodynamic characteristics. A mismatch at the leading edge interface of wing profile was noticed in the wings fabricated at the ADE. The mismatch was found to be uniform throughout the length of the leading edge. The leading edge is shown in Fig. 2. The leading edge is made up of polyurethane foam and glass fiber-reinforced composites, with metallic channel embedded for fastening the leading edge to the wing structure. On visual examination it was suspected that the metallic channel was opening out during riveting, leading to mismatch. Staff of the assembly team, who was fabricating the wing, supported this view. They had also found it difficult to insert the leading edge before riveting, and it was possible that the channel was opening out at the time of insertion. To verify this, measurements of thickness at 20 per cent chord (leading edge interface) were carried out on the leading edge (before assembly) and assembled onto the wing, separately. The readings are tabulated (Table 1). As observed from measurements, the thickness at 20 per cent chord had increased by 2 mm as compared to non-assembled leading edges. This may be due to either opening out of metallic channel in the leading edge, or additional thickness due to painting, or due to sealing compound.

An increase of about 0.5 mm is attributed to the thickness of painting and sealing compound. For further investigation, the mould for the fabrication

Figure 2(a). Leading edge interface of wing profile

Figure 2(b). Wing leading edge during assembly

of the leading edge was inspected and it was found that there was no locator in the mould for locating the metallic channel. These metallic channels are fabricated with extra length to cater for trimming during assembly, and also the channel has a compound taper. Because of these reasons, improper trimming can lead to decrease in thickness of channels, creating problems during assembly. The mould was

then corrected by giving a locator for the channel. The next wing was subsequently fabricated and thickness measurements showed no mismatch at the leading edge. The readings are given in Table 2. It was also found that some local undulations during fabrication (riveting) cannot be eliminated but can be corrected during putty and painting work. It was suggested that the putty work and subsequent emerying be carried out along the wing profile to get smooth wing contour.

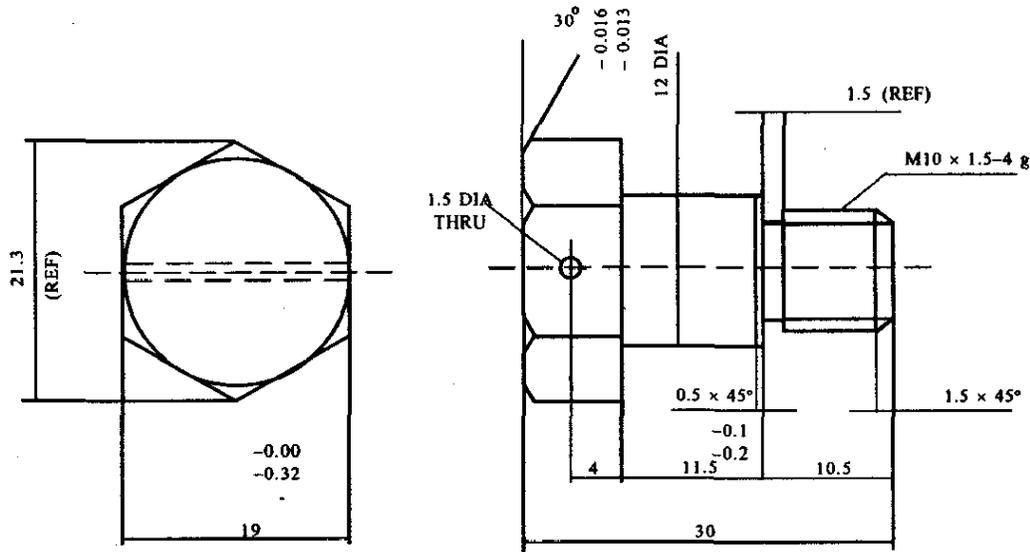
Figure 3. Wing-fuselage attachment bolt

The wing fuselage attachment bolt is a critical component on the UAV *Lakshya*. On investigation, it was found that some bolts were defective, and the threads were damaged on all the bolts. Also, the visual examination of the bolts and the attachment bracket revealed that the helicoil insert was wrongly installed by insufficient drill depth, leading to the damage on the threads. The bolt heads revealed extensive marks of deformed shape at the head portions. This was attributed to improper torquing of the bolts. The bolt is shown in Fig. 3. After process, specification for the installation of helicoil inserts was specified in the drawings. As a result of this study the thread damage in subsequent assemblies was reduced.

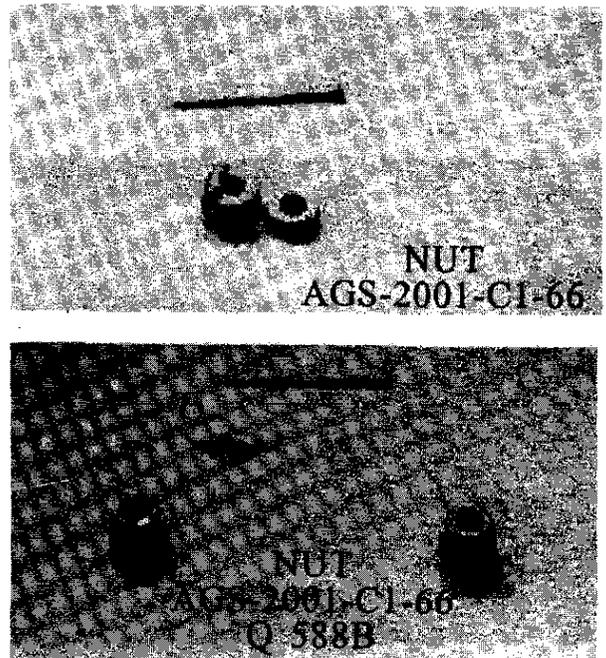
The unmanned aircraft *Lakshya* uses some of the aircraft general stores which are available on catalogue numbers. The stiff nut connects the tail plane to the rear fuselage and is critical one from the flight point of view. The part was AGS-2001-C1-66 as shown in Fig. 4 and was found defective. On visual observations it was found that the item used did not have the marketing of the manufacturer, and the nut had failed due to overtorquing as can be observed seeing the damages at the ends of the nut.

Figure 4. Stiff nut connecting the tail plane to the rear fuselage.
