## Failure Analysis towards Reliable Performance of Aero-Engines

T. Jayakumar, N.G. Muralidharan, N. Raghu, K.V. Kasiviswanathan and Baldev Raj  
*Indira Gandhi Centre for Atomic Research, Kalpakkam - 603 102.*

This paper highlights the failure investigations on two aero-engine turbine blades.

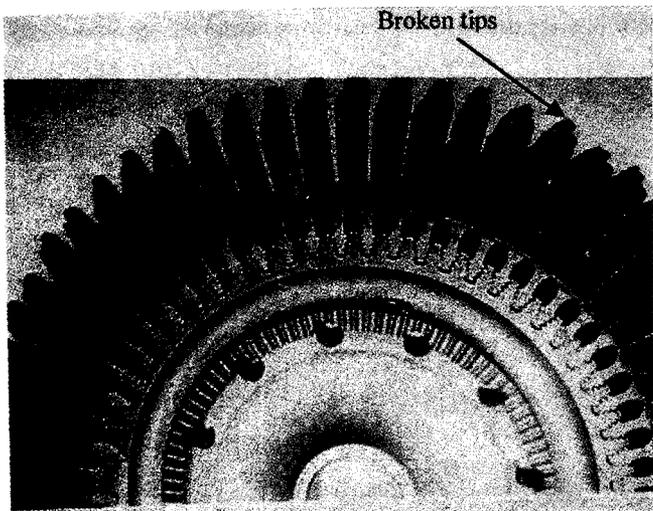
Figure 1. Failed turbine blades

chamber was also provided with a number of thermocouples to measure the compressor inlet gas temperature. At the time of failure, abnormal sound was heard followed by the engine failure, and the speed of the compressor came down to 2 per cent and the gas temperature also reduced drastically. Strip out examination revealed total failure of the shroud tips of all the 61 blades in the first stage and 71 blades in the second stage (Fig. 1). In addition to this, partial melting of the thermocouple heads fitted to the first nozzle diaphragm assembly was also noticed. The casing appeared bluish, and the blade debris was found strewn throughout the casing. The failed shroud tips were found blunt.

Temperature monitoring device is to be augmented to detect excess heating of the aero-engine beyond the acceptable limits. Better quality control of the protective coatings during overhauls is recommended to avoid over temperature exposure leading to microstructural changes during service.

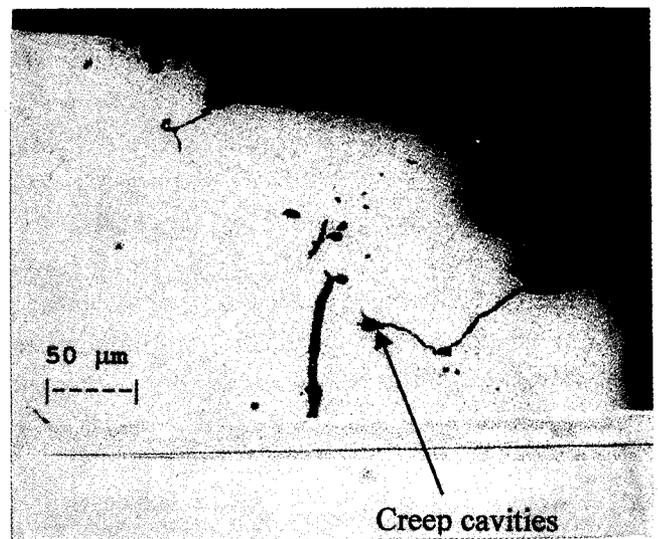
Metallographic examination were conducted on the failed blades, unused blades and partially-used (500 hr blades). Examination of the failed blades revealed a lot of creep cavities as shown in Fig. 2. The protective aluminide coating was also found to have spalled and dislodged from the surface as shown in Fig. 3. The etched surface revealed grain coarsening; absence of gamma prime precipitates in the gamma matrix and grain boundary carbides as shown in Fig. 4. Cracking of the grain boundary carbides was also seen on a number of places. The microstructure of the

Figure 2. Polished first stage blade showing creep damage

The total absence of the strengthening precipitates in the matrix of blades, presence of creep cavities on the grain boundaries, excessive grain growth and cracking of grain boundary carbides confirm<sup>1,2</sup> over temperature exposure to approximately 1313-1373K. The dislodgement of the protective coating and melt down of the thermocouples confirm that the temperature was not within the normal operating range. Creep occurs readily at an elevated temperature due to reduction in strength by the dissolution of gamma prime precipitates and also due to grain coarsening. As a result of overageing, there was appreciable grain growth and segregation of carbides at grain boundaries.

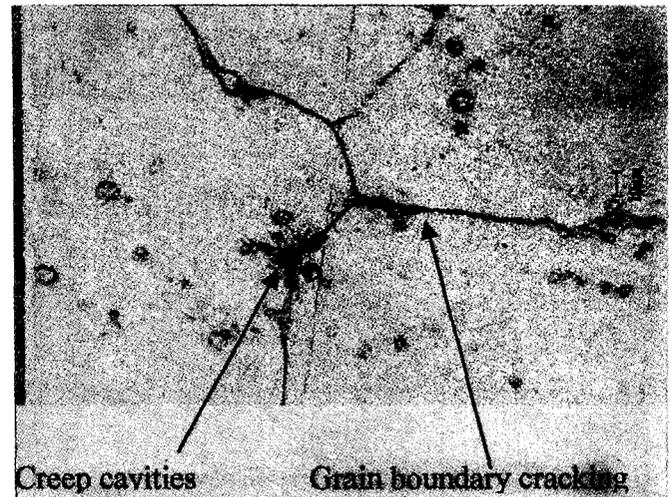
Figure 4. Photomicrograph showing creep cavities and cracking of grain boundary carbides.

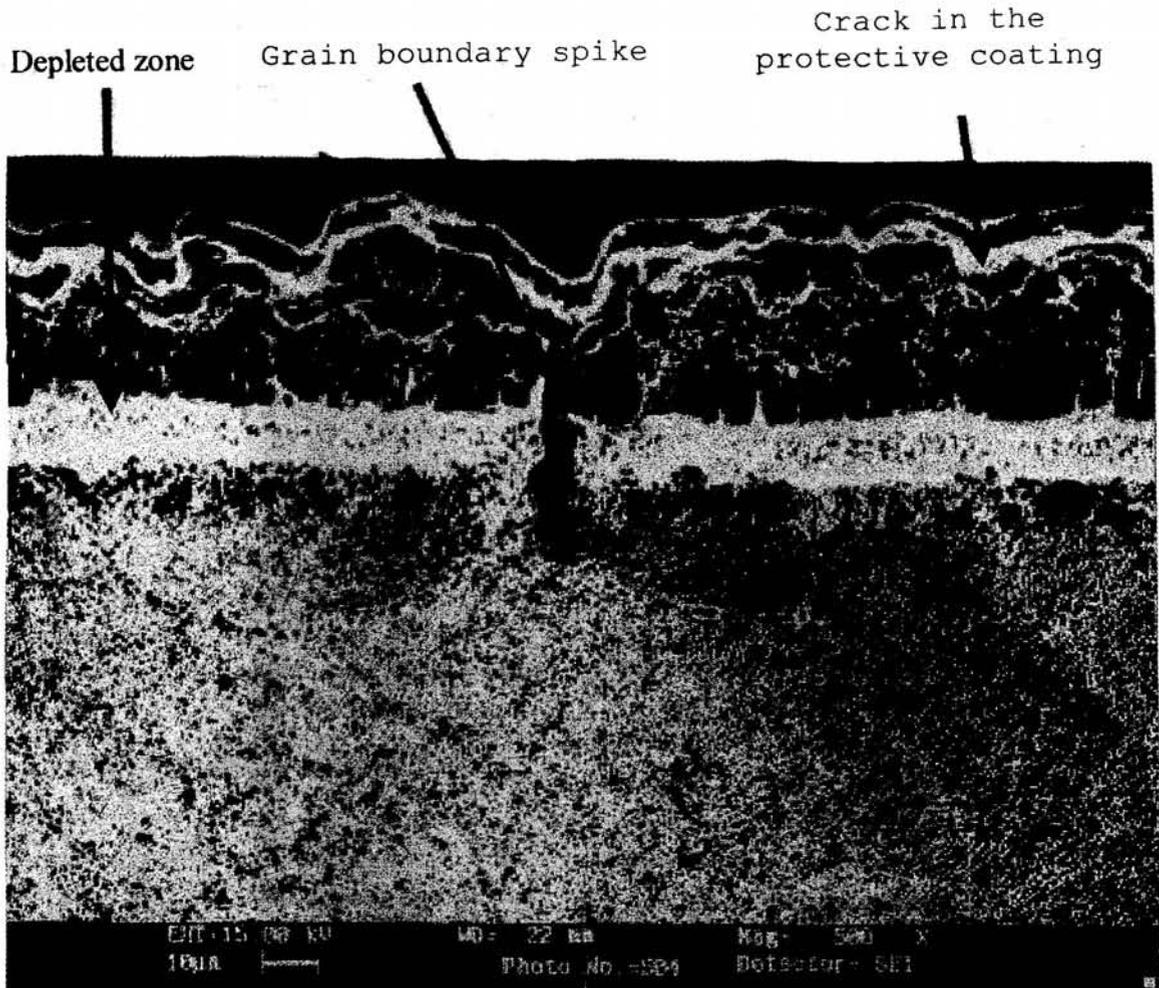
Figure 6. SEM photomicrograph showing hot corrosion damage

Metallographic observations revealed that the failed turbine blade had undergone non-layer form of hot corrosion damage due to combined action of oxidation and sulphidation<sup>3</sup>. The high temperature form of hot corrosion is attributed to the action of condensed salts deposits formed by the combustion between the sulphur in the fuel and the sodium present either in the fuel or in the ingested air. Presence of grain boundary spikes and matrix-depleted zones along with cracks in the coating are typical indications for non-layer form of hot corrosion.

Hot corrosion damage leads to loss of cross-sectional area due to corrosive material wastage. The superalloys used under this service condition gets weakened due to depletion of hardening elements and gamma prime precipitates. The corrosion-induced changes in the surface morphology and the alloy microstructure facilitate creep-crack initiation and its propagation. The reduction in fatigue strength and endurance limit are mainly due to corrosion-induced surface changes, such as pits, notches, precipitate-depleted weak zone, grain boundary spike, etc. and facilitate fatigue-crack initiation.

Limitation of sulphur and alkali contents in the fuel through careful control of specification is recommended. Stringent specifications for the quality control of protective surface coating during manufacture

and subsequent inspection overhauls can significantly reduce the failure incidents.
