## Add-on Armour Repair – Concepts & Techniques

S.N. Dikshit

*Defence Metallurgical Research Laboratory, Hyderabad 500 058*

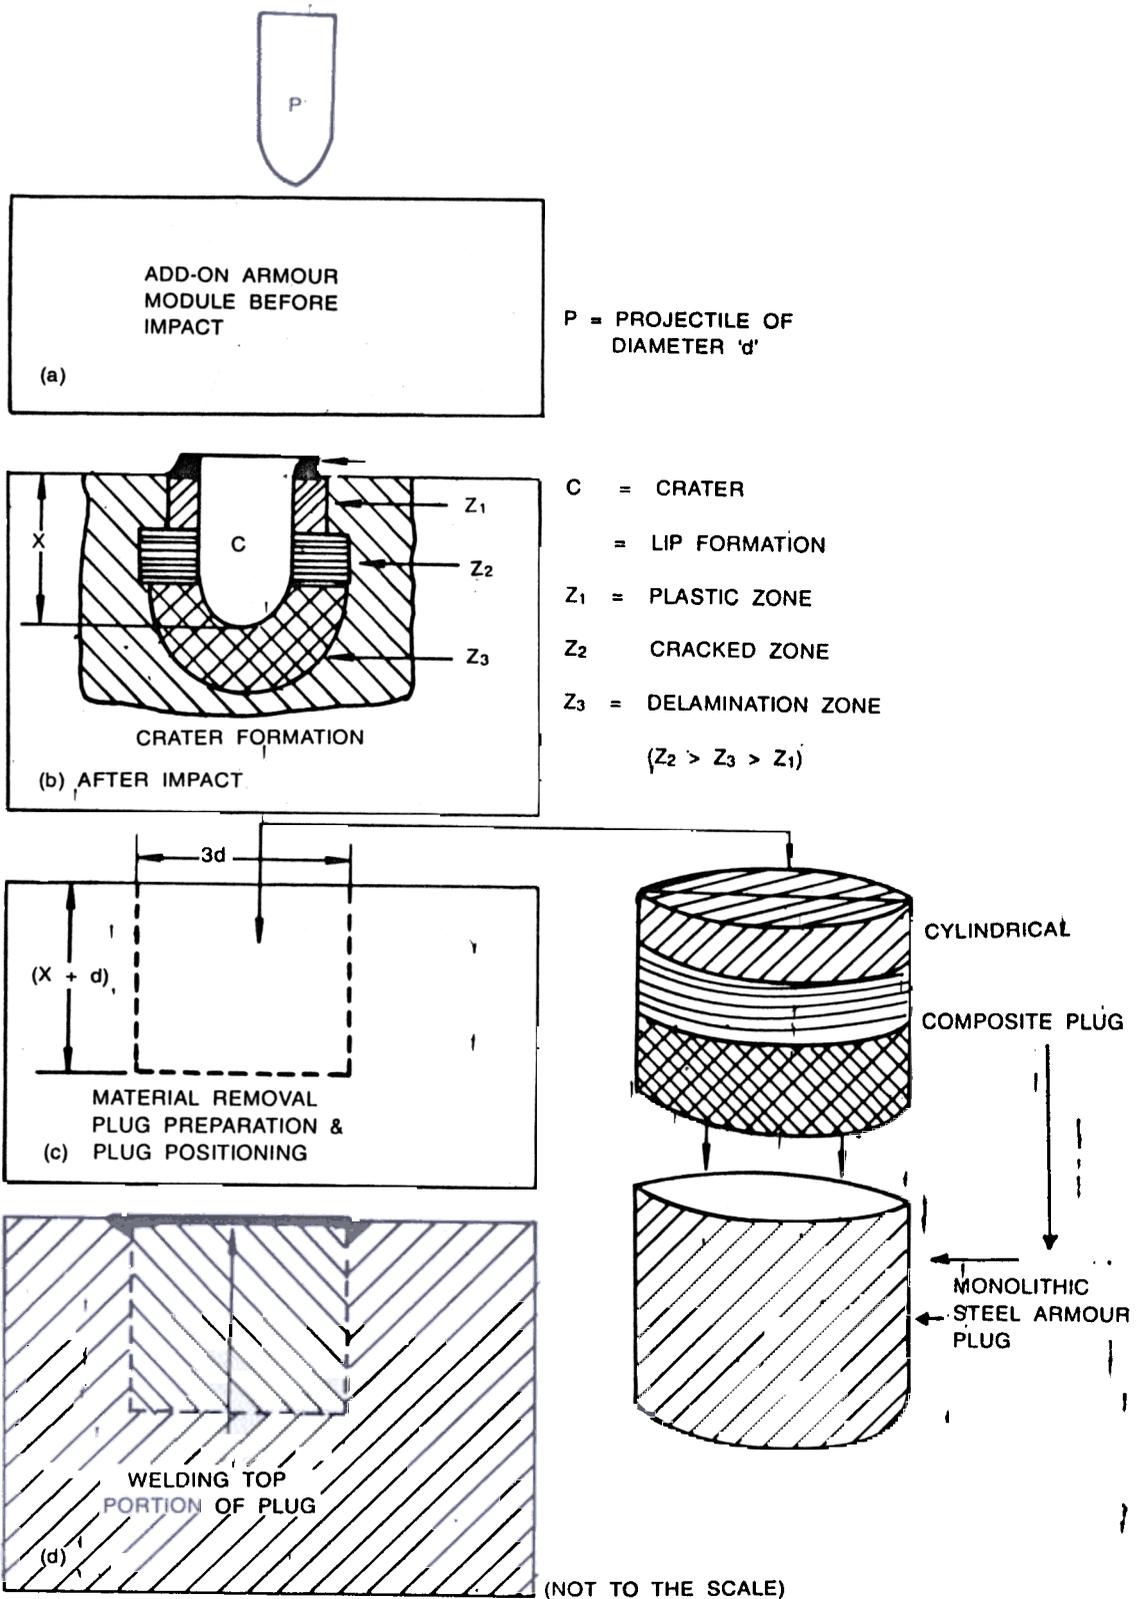
Figure 1. Crater formation at zero obliquity and its repair

As the primary aim of these repairs is to restore ballistic worth of the add-on panel, the repair agency will have to ensure that the damaged material layers are removed from the impact site. As a thumb rule, an area equal to three times the diameter of the crater<sup>7</sup> is to be removed and filled with new material in that sequence. In an emergency repair situation where all kinds of materials are not readily available, armour grade material available as rolled homogeneous armour plate can be utilised to fill the damaged portion of the panel, both in the zero and non-zero angles of attack. It is observed that a monolithic cylindrical plug meets the ballistic requirement and one should not hesitate to use such a plug under field conditions.

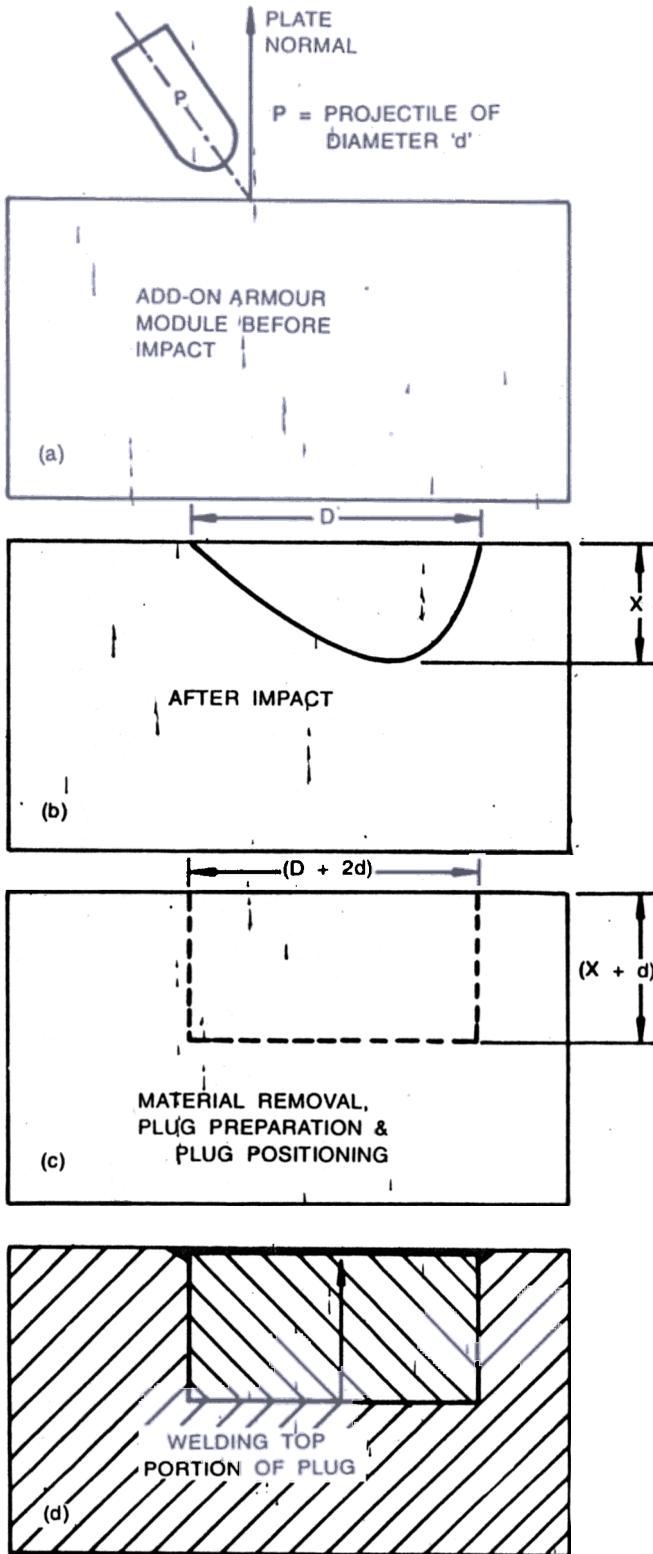
Figure 2. Crater formation at high obliquity and its repair
