## Corrosion Failures in Marine Environment

R. KRISHNAN

Naval Chemical & Metallurgical Laboratory, Bombay-400 023

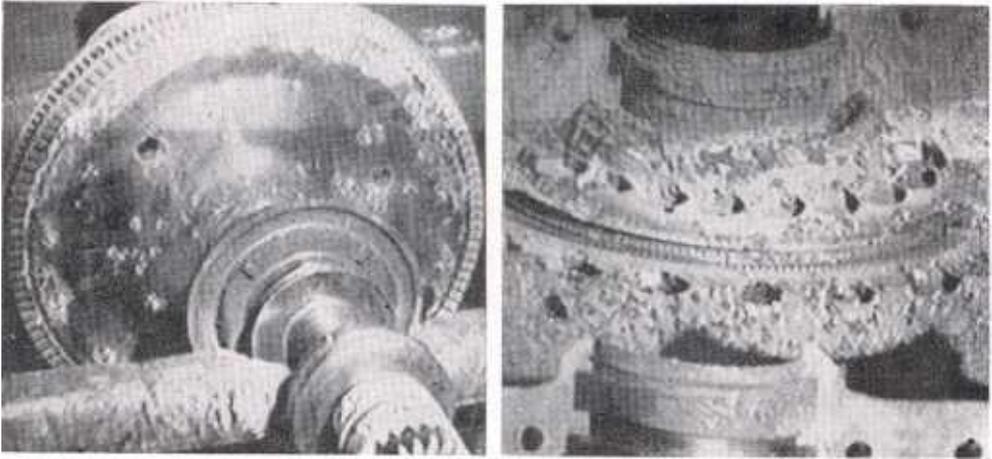
Pitting corrosion observed on the impeller and housing of a two-stage steam turbine after a very short service is shown in Fig. 1. The impeller was made of martensitic grade stainless steel, while the casing was made of plain carbon steel. The turbine was run by super saturated steam. Special quality boiler feed water was converted to steam and fed to the impeller of the steam turbine. Then, the heat of the low pressure

(a) (b)  
Figure 1 (a & b). Typical chloride pitting of impeller and housing.

steam was abstracted from it by cooling in seawater in the condenser and water was recirculated. It was observed that the chloride content of the fresh water was more than the specified limits, suggesting that the chloride induced pitting was due to an ingress of seawater through the condenser leakage.

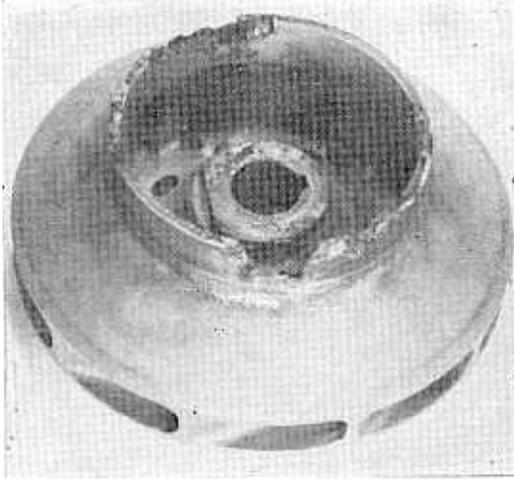
The aluminium impeller of a pump of a closed loop fresh water recirculating system which has suffered corrosion damage is shown in Fig. 2. The impellers were of a main engine driven pump used to circulate fresh water with 1-2 per cent potassium dichromate to the main engine cylinder liners for cooling. The heat of the warm water was extracted by passing it through the copper coils immersed in seawater. A rubber gasket was provided at each joint between the copper and aluminium tubes.

Figure 2. Aluminium impeller failed in service due to galvanic attack.

Chemical analysis of the material of construction of the impeller and the housing revealed that they were of Al-Si alloy as per design specifications. The chemical analysis of the water indicated the presence of copper in the ppm range. The  $pH$  of the solution was found to be 4.7. Dissolution of copper takes place in the acidified medium. In the stagnant condition, the dissolved copper had formed a galvanic coupling with the aluminium alloy in the electrolyte, thereby leading to the corrosion of less noble aluminium.

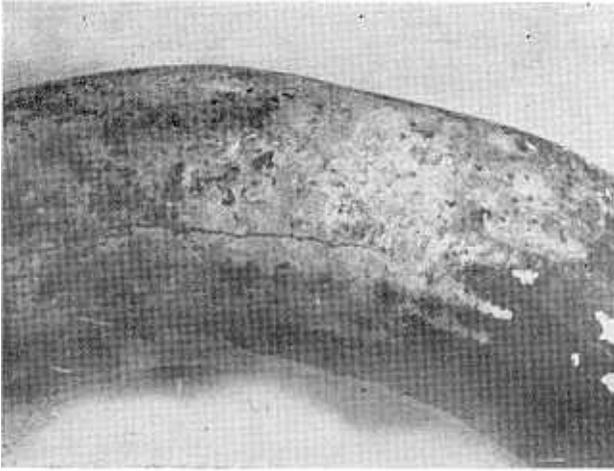
The crack in the outlet tube end of a forced draught blower of a lubricating oil cooling system made from Muntz metal (60 : 40 brass) is shown in Fig 3. The lubricating oil at a temperature of 60°C is being cooled by seawater passing outside the tube at a pressure of 15 psi. On visual examination, radial cracks with reddish corrosion deposits were observed on the surface. Metallographic examination revealed clear evidence of dezincification. The salinity of seawater coupled with the high temperature was responsible for this failure.

**Figure 3.** Crack and deposits in a Muntz metal tube.

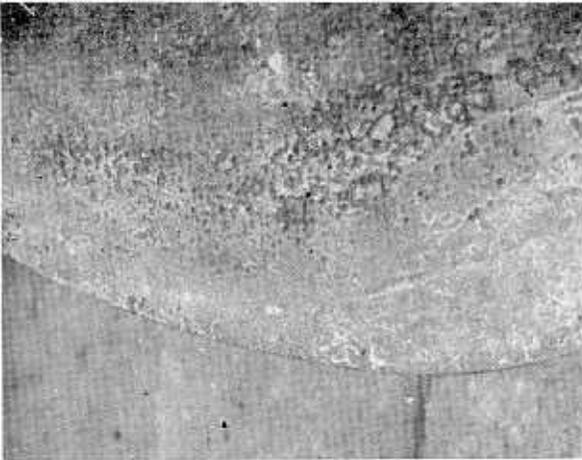
The cavitation damage suffered by a four pitched propellor blade made of aluminium bronze conforming to BS 1400 AB2 is shown in Fig. 4. The propeller was working at an average speed of 600 rpm. It has been reported that with increase in speed of the propeller gross cavitation can be expected to occur at shorter time periods.

**Figure 4.** Aluminium bronze propeller blade showing typical cavitation.

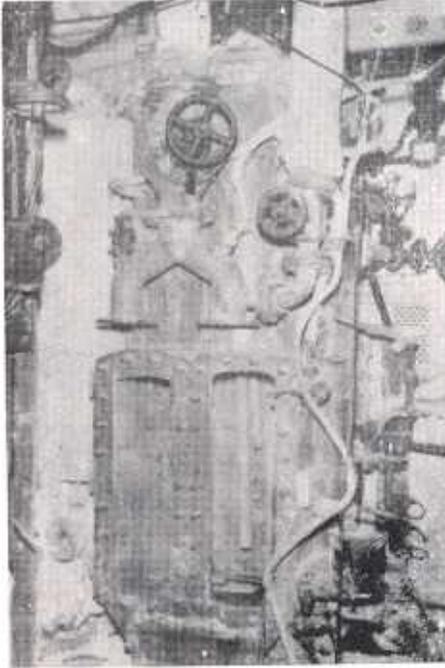
**Figure 5.** General view of the seawater evaporator.

The general view of the seawater evaporator shell is shown in Fig. 5. It is primarily a heat transfer system, where heat is supplied to the coil by steam and is transmitted to seawater giving fresh water vapour and leaving behind salt and other solid deposits. The evaporator shell was made of 15 inch diameter annealed temper naval brass plate of 3 mm thickness. The shell was fabricated by welding and no postweld stress relieving was reported to have been carried out. Two cracks in the shell body slightly away from the welded zone are shown in Fig. 6. Chemical analysis showed that the tin content of the shell plate was less than the specified minimum of 1.2 per cent. Microstructural examination revealed grain boundary precipitation which was identified to be  $\text{Cu}_3\text{Sn}$ . Abnormal segregation of tin near the crack tip as well as at the grain boundaries was also noticed. Although tin is intentionally added to brass for reducing dezincification, abnormal segregation of tin at the grain boundary has contributed to the failure of the brass in stress corrosion cracking (SCC).

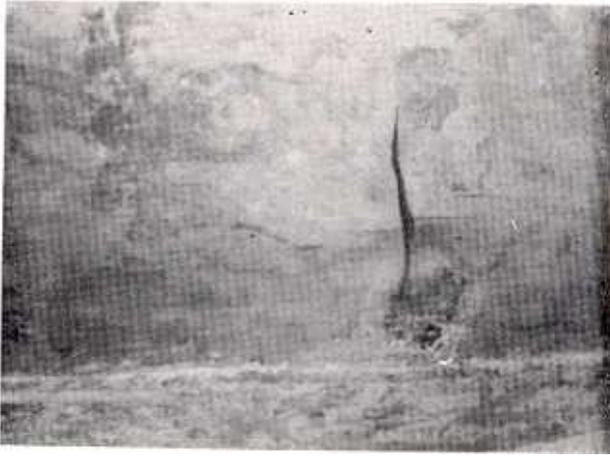
**Figure 6.** Macrograph showing two cracks on the shell body.
