FAILURE OF MARINE BOILER TUBE : A CASE HISTORY

V. A. DERE and M. Y. BORKAR

Naval Chemical and Metallurgical Laboratory, Bombay

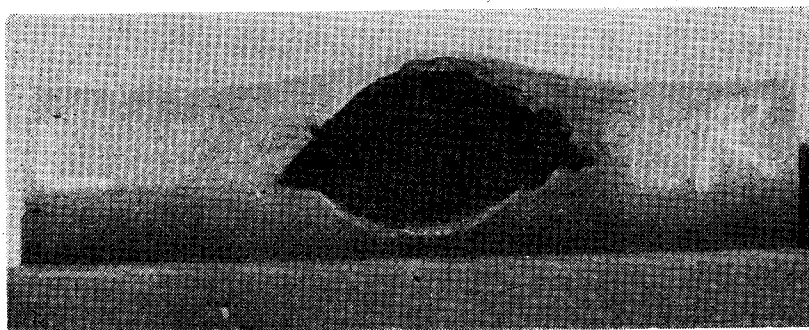
The length of the tube measured approximately 236.22 cm. (93") and the burst was located at a distance of about 79.75 cm. (31") from the water drum end of the tube. A photograph of the tube where the burst had occurred was taken and this is shown in Fig(1).

FIG. 1. *The tube showing the burst.*

- (a) Some amount of stretching and thinning of the wall near the burst had taken place. The normal wall thickness was 0.307 cm (0.121"), while near the fringe of the burst it had been reduced to 0.285 cm (0.112").
- (b) A few pits were observed on the inner surface and the parting line of the burst contained two such pits, 1.25 cm. from one another. Fig. (2).

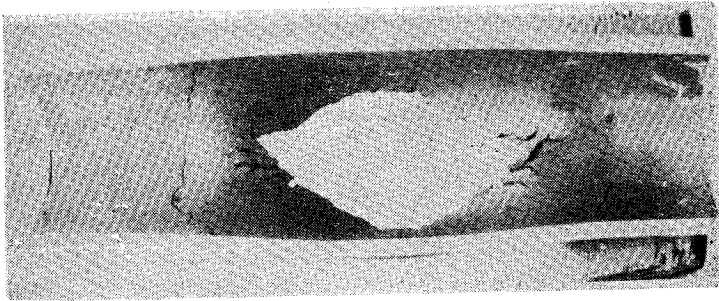
FIG. 2. *Inner water side of the tube showing pits and cracks.*

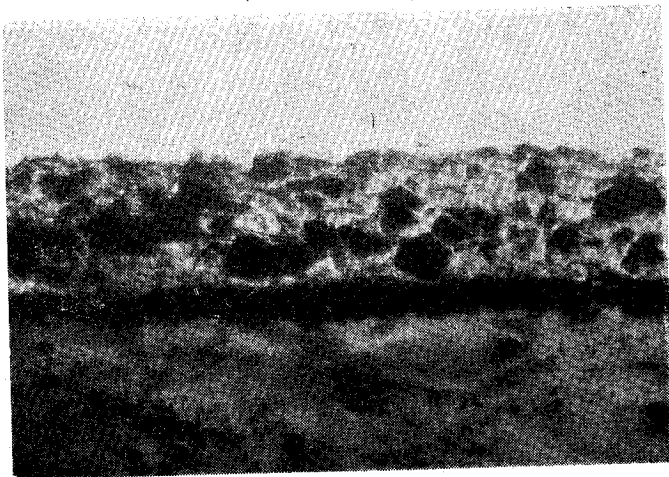
- (c) A thick black deposit (Fig. 3) was seen adhering to the inner surface. Where the deposit had flaked off, a thin film of metallic copper could be observed. There is no doubt the copper has emanated from the auxiliary equipments of the boiler. The importance of copper arises from the fact that being cathodic to iron, its presence can lead to the pitting of the tube.

FIG. 3. *Showing black deposit on the inner surface of the tube.*

The sample was polished and examined along the cross-section. The thickness of the deposit was found to be 0.051 cm (0.02").

(a) Excess overheating of the tube, facing the fire, occurred. This was locally accelerated by the internal deposit of heat insulating material (Fig. 3).

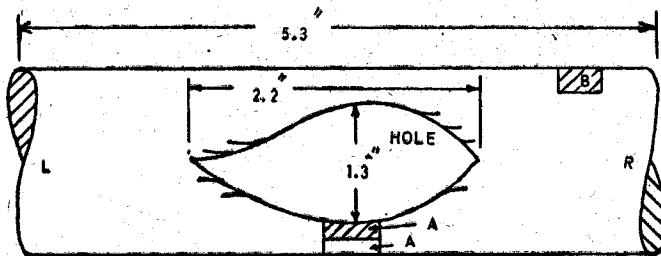
FIG. 4. Line Sketch

The fractured portion of the tube was examined under stereo microscope. It was observed that the cracks were generally circumferential. No visible cracks were seen beyond $1/2$ " from the fractured end. There was evidence of bulging without any cracks, that is, the metal had become ductile.

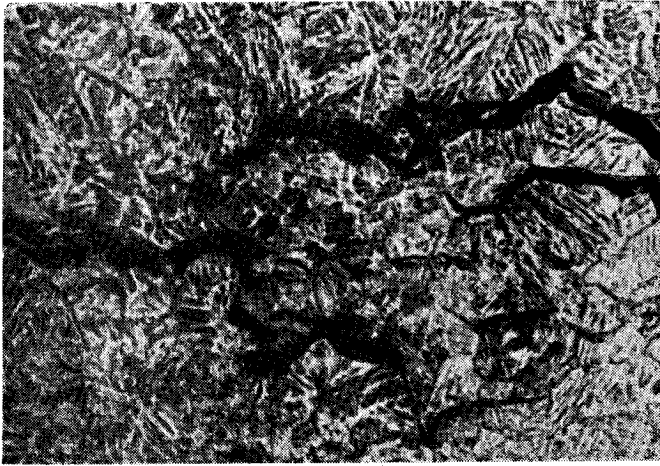
It was obvious that the metal had been heated to about 1650°F before being rapidly quenched by the tremendous flow of steam and water through the burst. Typical microstructure of two areas of specimen A are shown in Fig. 6 and Fig. 7, which show that the crack tended to follow the grain boundaries. A few tips of the crack enter into the grains also. The grain size is coarse revealing Widmanstätten structure.

FIG. 6. *Microphotograph showing Widmanstätten structure and some cracks entering the grains*

(c) At the time of rupture, the flow of steam and water effectively quenched the over heated metal, as is evident from the Widmanstatten Structure (Fig. 6 and 7).

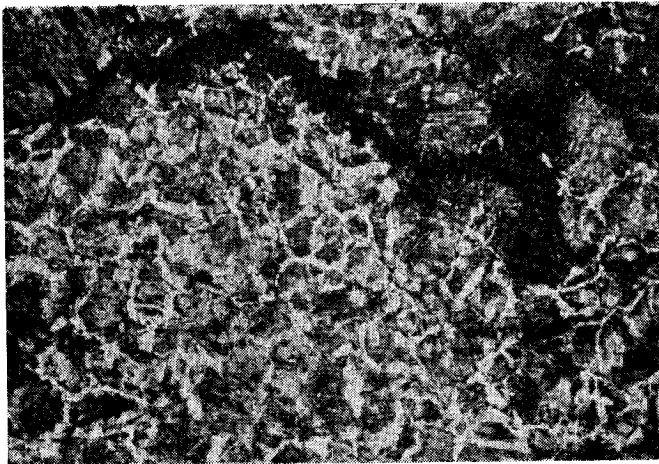
FIG. 7. *Shows Widmanstätten structure as in Fig. 6*

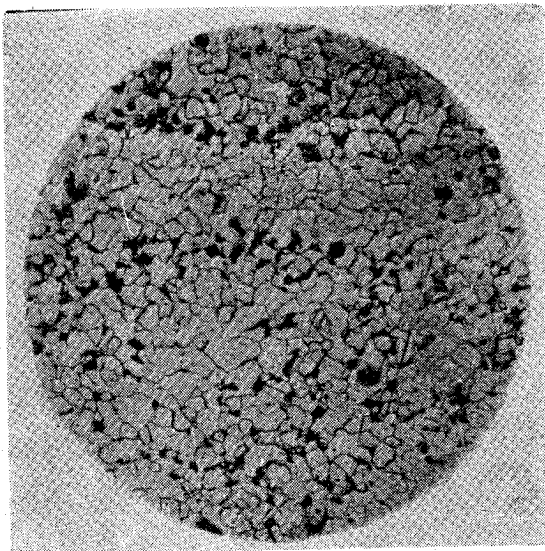
Normal structure of fine grains of ferrite and pearlite was revealed (Fig. 8).

FIG. 8. Showing fine grains of ferrite and pearlite.
