Failure Behaviours of Steel Projectiles with Localised Melting Against Armour Plates

ABSTRACT

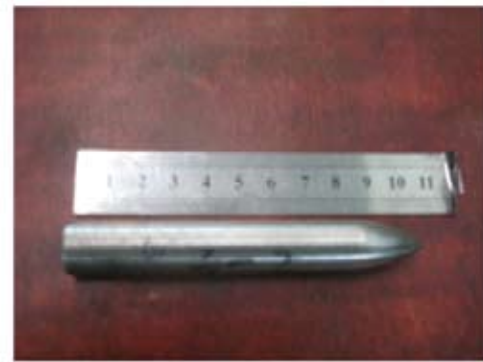
Figure 2. (a) The projectile used in the experiment (b) The geometry and dimensions in mm.

The material of projectile was 30CrMnSiNi2A steel, and the main compositions were seen in Table 1. The projectiles were machined with an oval shape (CRH=3.0), and the overall length is 102 mm. To meet the requirement of speed, a hollow structure is adopted to reduce the launching weight, as shown in Fig. 2. All projectiles are pre-heat treated to make Rockwell hardness up to 40. The main parameters of heat treatment were described in Table 2. The dynamic mechanical properties of 30CrMnSiNi2A steel with Split-Hopkinson pressure bar and static material test system within five strain rates were shown in Fig. 3, it is seen that the yield stress is about 1580 MPa at the strain rate of $10^{-4} s^{-1}$, while that increases to 1682 MPa at $500 s^{-1}$ strain rate. During the increase of strain rate from $500 s^{-1}$ to $5000 s^{-1}$, the yield stress of the material increases gradually(1682~1920 MPa), but the variation is slight. It is notable that 30CrMnSiNi2A steel is less sensitive to the strain rate.

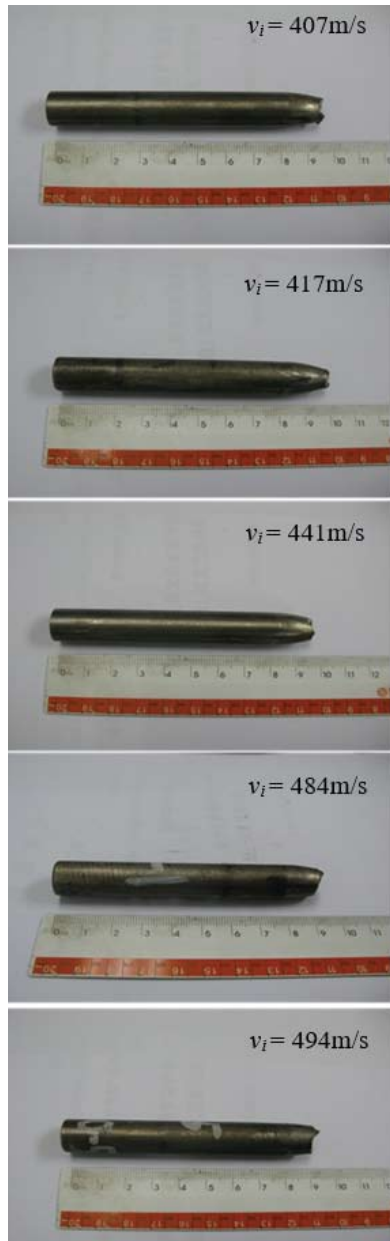
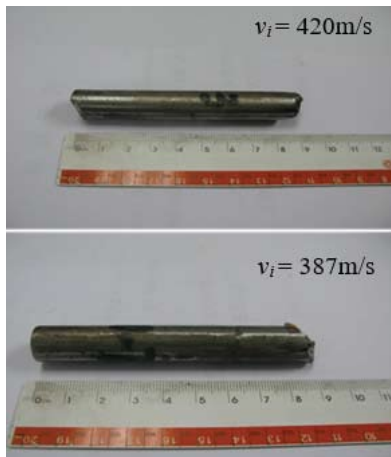
Figure 5. The photographs of the projectiles recovered with target of (a) 4 mm thickness and (b) 6 mm thickness.

During perforation of armour steel, projectiles experience high loads of short duration, which may be the primary factor for failure. The results of macroscopic inspection in Fig. 5 indicated that the integrated projectiles still maintained, instead of damage largely confining to the projectile nose.

Compared with the original, the mass loss of the residual projectile is larger and the nose cracks. Notable is the relative small amount of fracture in the nose region, which can be described in terms of velocity discontinuities identified by

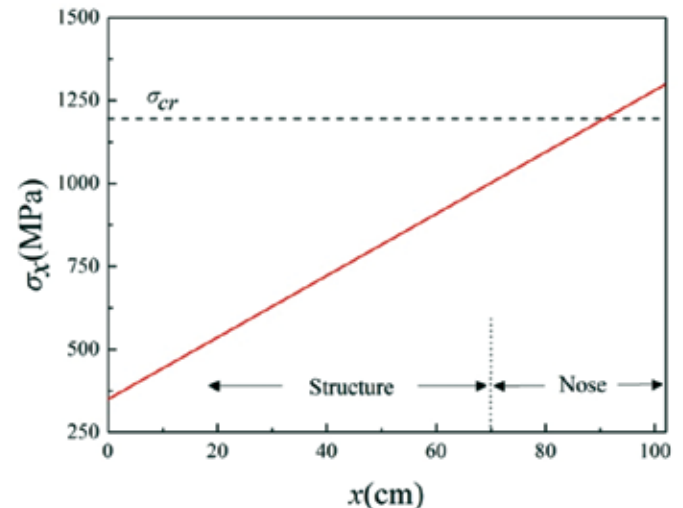
Figure 10. The variation of σ_x with x for projectile striking target plate at 407 m/s.

The variation of the compressive stress in projectile wall with the distance from projectile tail is shown in Fig. 10. It is shown that the compressive stress σ_x increases with the distance x increasing, and the nose of projectile must resist the maximum compressive stress. When the maximum value of σ_x equals the failure stress of the projectile material σ_{cr} , the head of the projectile will be damaged¹². On the other hand, the integrity of local melting zone at the main structure is stable, this conclusion is in line with the results of experimental observation.
