## Cyclic Loading on Composite Repair of Corroded Steel Pipelines

The study aims to determine how cyclic loading affects the structural integrity and lifespan of composite repair systems used to restore corroded steel pipelines. As specified in Annexure C of the ISO 24817 repair code, pipe specimens are machined to produce flaws with 80 % wall loss. Testing under static and cyclic pressure loading is done as per ASTM D2992 and ASTM D2143. Static pressure loading is accomplished by continually pressurizing the pipe specimen, and burst pressure is assessed. Various Rc-ratios or levels of cyclic loading severity are used in cyclic pressure loading tests. Each case's number of cycles before failure is determined experimentally, and the service de-rating factor is assessed in accordance with ISO 24817. The 235 bar pressure was sustained by the static-loaded repaired pipe specimens with 80 % wall loss, and the failure was catastrophic. At around 7000 cycles, the cyclically loaded repaired samples with 80 % wall loss failed, and the failure manifests as debonding or a leak.

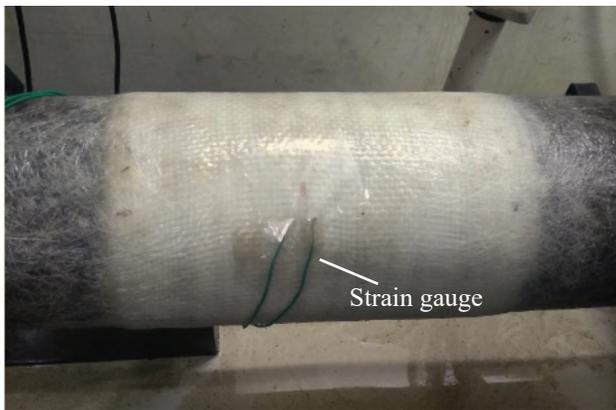
**Figure 5. Strain gauge mounted in the circumferential direction over the defect.**

This can be used as a factor to discuss the loss of structural integrity due to cyclic loading. In this study strain-life fatigue ( $\epsilon$ -N) approach is used to estimate the life of the repair. While performing the tests, strain gauges are mounted in the circumferential direction on the defect region, as shown in Fig. 5. A pressure gauge is also mounted on the blind flange opposite the pressurizing side. A data acquisition system consisting of a strain indicator and an oscilloscope is used to acquire the live strain data from the strain gauge mounted on the test pipe specimen, as shown in Fig. 6. Plots of varying strain vs. time can be used to predict the number of cycles required for failure.

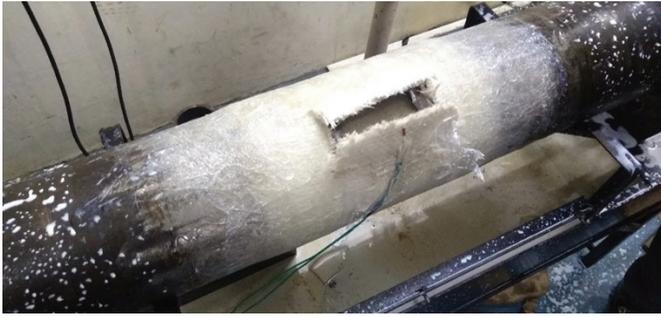
Figure 7. Failed specimen with 80 % wall loss.

The test pipe specimen with 80 % wall loss has been repaired with the specified wrap code of two layers of CSM-reinforced epoxy and four layers of WRM-reinforced epoxy. The repaired test specimen is mounted onto the cycling loading setup and is pressurized incrementally until failure. The repaired sample failed at a pressure of 235 bar. The complete notch portion has opened up, breaking the epoxy filled in it into pieces, and fiber failure is observed along with debonding. The failed specimen is shown below in Fig. 7.
