# REMOVAL OF EXTERNAL DEPOSITS ON BOILER TUBES

C. P. DE, J. C. CHAUDHURI, K. P. BUCH & A. K. AUDI

Naval Chemical and Metallurgical Laboratory, Bombay

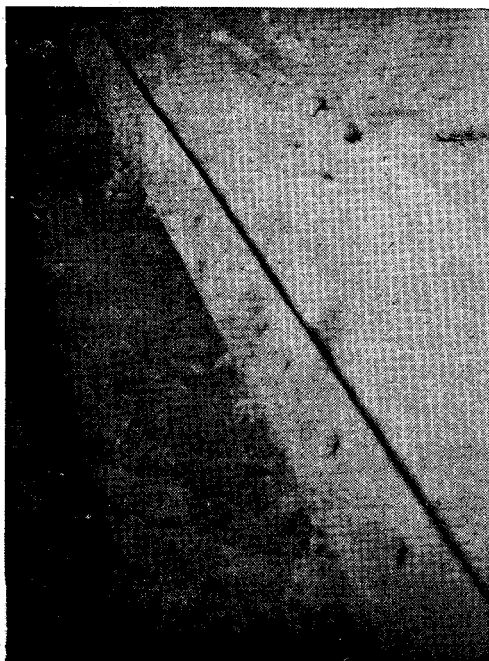
*Chemical nature of the deposits* : The deposits were black. Lumps of the deposits collected from the header end superheater tubes, when broken showed yellow materials inside. The deposits were found to be feebly conducting and feebly magnetic. On chemical analysis, neither the Port nor the Starboard boiler deposits showed any presence of iron or its oxides. The deposits on the Port boiler consisted mainly of sodium sulphate and vanadium pentoxide together with small amount of sulphates of magnesium, calcium, and nickel, nickel oxide, silica, organic matter and carbon. The deposits on the starboard boiler showed,

in addition, presence of chromium oxide. Fig. 1 shows the condition of rows of superheater tubes at the header end before cleaning. All tubes and intervening gaps are covered with vanadium rich deposits. Fig. 2 shows the condition of the superheater bends before cleaning the deposits. The view is exposed after removing the BW 5 baffle wall tube. The thick deposits are visible on each bend from top to bottom. The analytical data on the two samples, one from the port and the other from the starboard boiler are given in Table 1.

Fig. 1—Plugging of superheater tubes by vanadium rich deposits.

The reaction is exothermic. On further studies with regard to concentration and time, it was found that 15-20 per cent hydrogen peroxide would be suitable for disintegrating the lumps *in situ*. Lower concentration was rather sluggish in effect and happened to take considerably longer time. Fig. 3 shows the condition of the same superheater tubes after cleaning with hydrogen peroxide. There is no deposit upon any tube after cleaning.

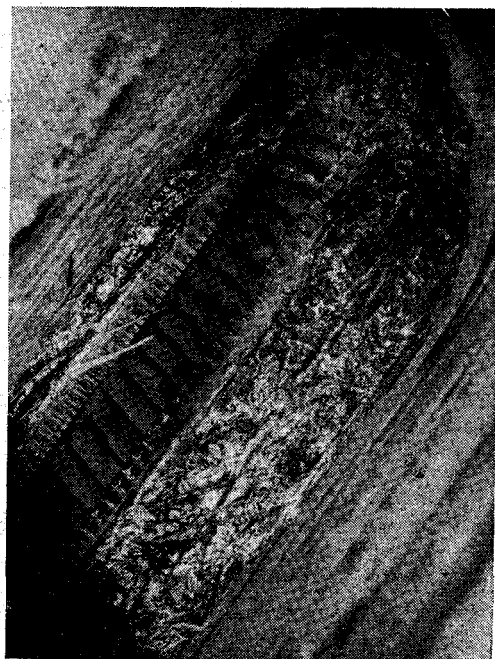
Fig. 2—Return bend of superheater covered with deposits.

In order to gain greater accessibility the BW 5 baffle wall tube of the boiler was removed, thus exposing the return bend of superheater tube for efficient cleaning.
