Analysis of Failure of Pin Locator for Internal Nose Cap of a Long Range Cruise Missile

ABSTRACT

A steel pin used as a locator for internal nose cap of long range cruise missile was found in cracked condition after it was subjected to transportation, vibration and bump tests. Metallurgical investigation was carried out with the failed pin. The crack was found to be inter-granular and a thin black oxide layer was observed on the fracture surface. Based on the evidence, it is concluded that the pin failed because of quench cracking and the crack was initiated prior to tempering and zinc plating.

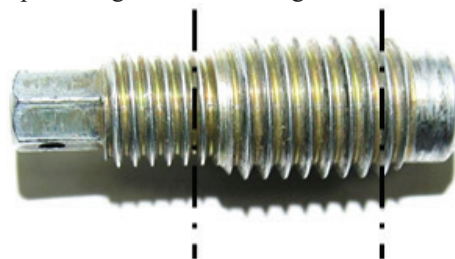
The defective pin was cut cross-sectional as per schematic presented in Fig. 4 and viewed under optical microscope. The optical micrograph shown in Fig. 5(a) reveals that the crack has propagated to a depth of 1/3rd of the diameter of the rod. The cut surface was polished and examined under optical microscopy. The optical image is given in Fig. 5(b). Figure 5(b) indicates a crack that had propagated in a zigzag pattern. To open the crack for fracture surface examination, the cross section portion with the crack was cut perpendicular to the depth of the crack along the length. After cutting across the crack length, the two mating surfaces of the crack were opened by a small amount of force and by giving a slot into the crack. The mating surfaces of the crack are shown in Fig. 6. The entire crack has shown dark black coloured surface except the force opened region which is bright.

Figure 4. Schematic showing the cutting of the pin. The portion between the lines was viewed under microscope.
